# HOLDEN FOLD DARWEN

## SHALLOW MINING SITE INVESTIGATION WORKS

**Job Number:** LKC 21 1081

**Client:** Blackburn with Darwen Borough Council

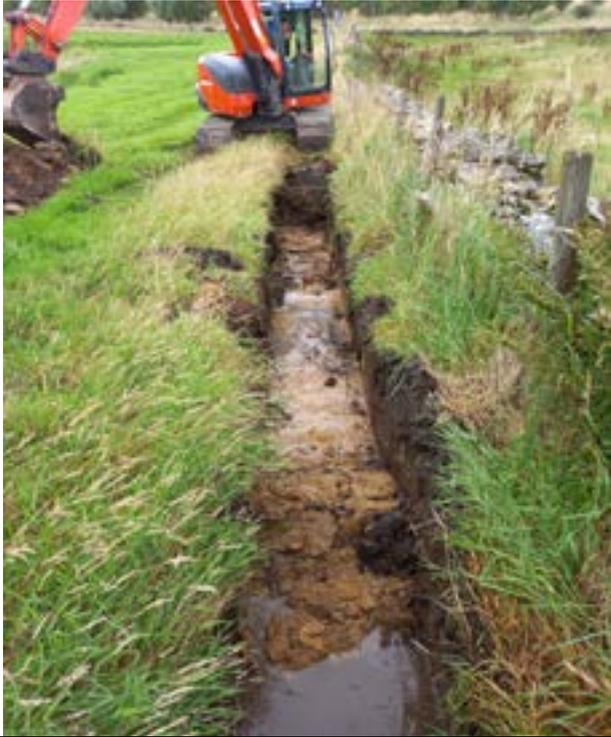
**Photograph 1:**  
Trial trench along the boundary wall / fence line exposing the light coloured clay superficial deposits.

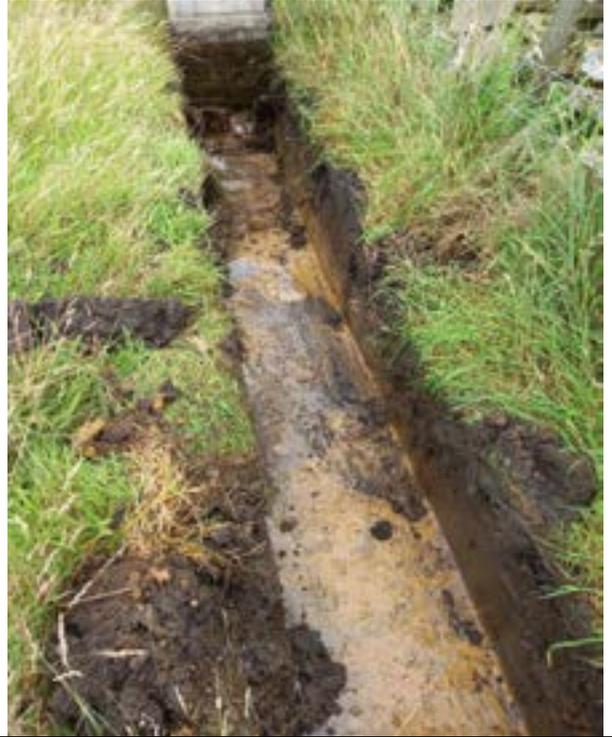
**Photograph 2:**  
Close up of the light coloured clay deposits in contrast to the topsoil seen in the side wall of the trial trench.

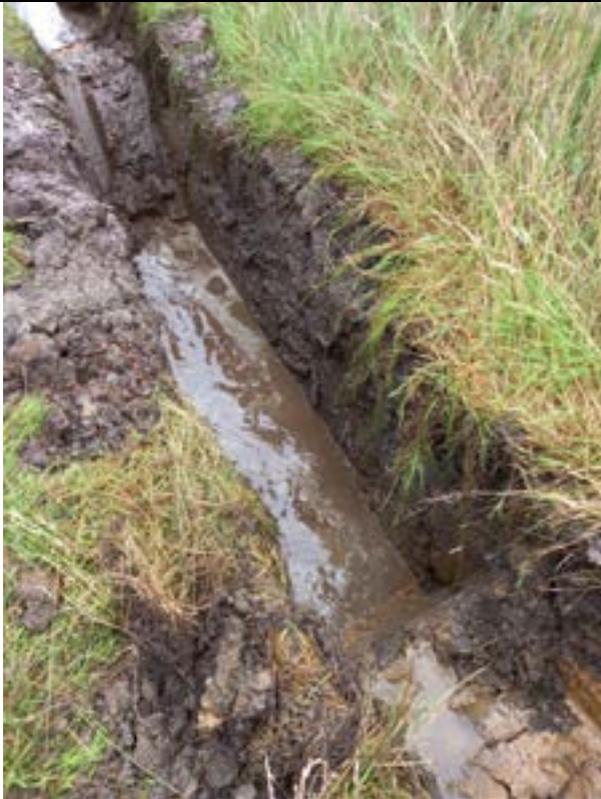
A possible mine entry was identified at the mapped location of the shaft. A light yellowish-brown clay encountered at 0.4mbgl gave way to black and grey ash, clinker and colliery spoil saturated with groundwater. A second trench was extended perpendicular to the initial trench to expose the extent of the made ground. The intersection of the trenches was also deepened at the location of the shaft to approximately 1.7mbgl; however, due to water influx and partial collapse of the trench side walls towards the drystone boundary wall excavations were terminated.

The area of made ground exposed appeared to be a semi-circle approximately 3m across with the remainder passing below the fence line/drystone wall.

**Photograph 3:**  
Possible mine shaft saturated with groundwater exposed with made ground penetrating the natural clay.

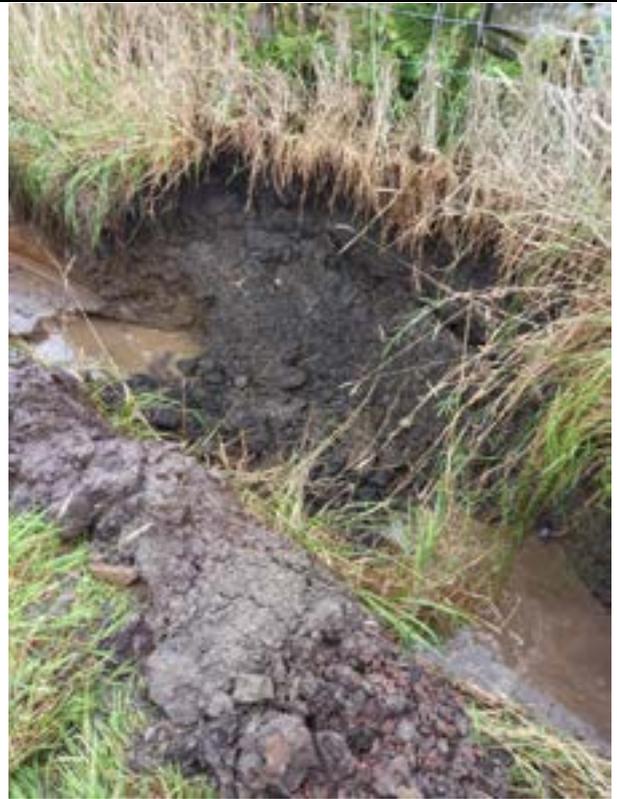
**Photograph 4:**  
Side wall collapse showing made ground within the possible shaft comprises ash, clinker and colliery spoil..

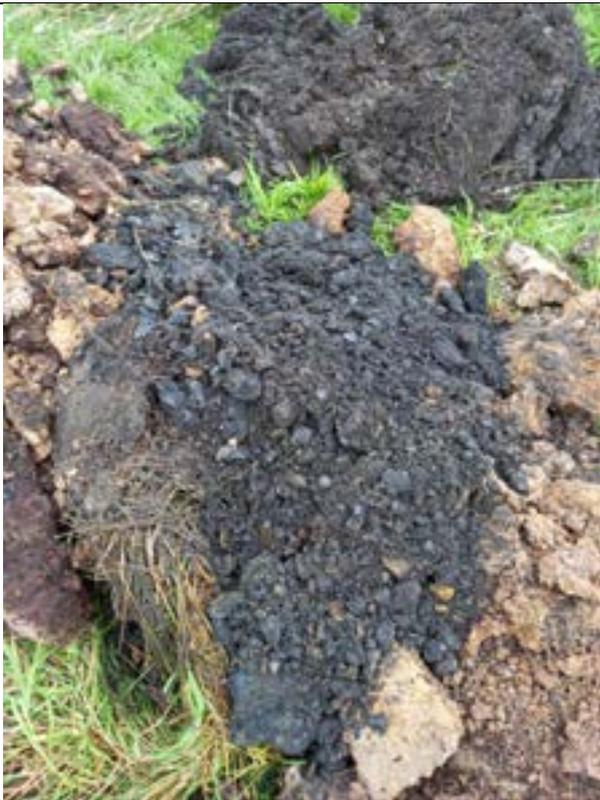
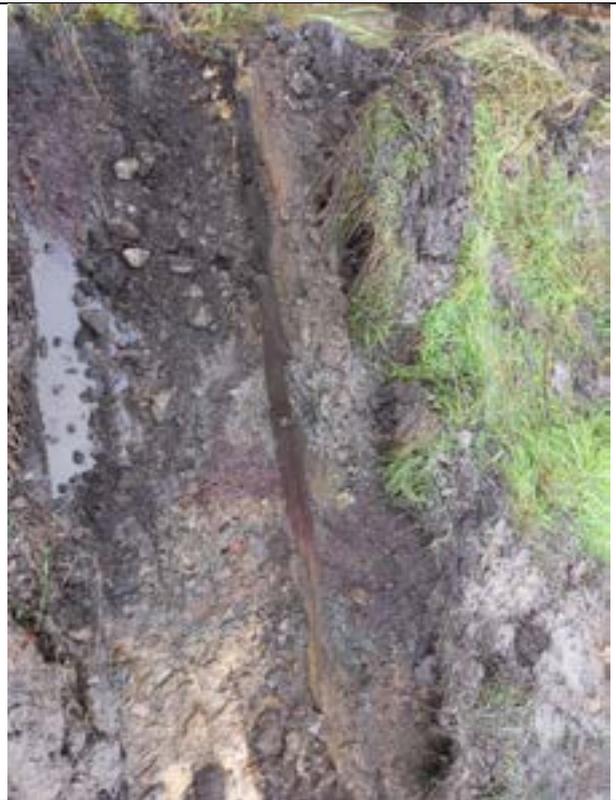
**Photograph 5:**  
Illustrating the contrast between the possible shaft fill material and the natural clay surrounding the potential shaft.

**Photograph 6:**  
Illustrating the contrast between the possible shaft fill material and the natural clay surrounding the potential shaft.

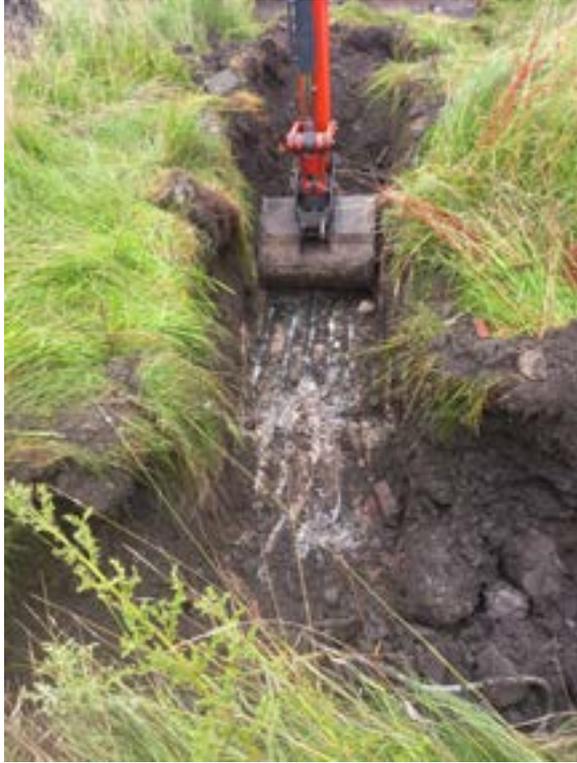
The southern edge of the concrete cap was located 1.2mbgl at the mapped location of the mine shaft. The centre of the cap is approximately 5m to the north of the mapped location. Trial trenches were extended across the slab to expose its limits demonstrating it to be approximately 8.5m x 8.5m.

**Photograph 7:**  
Initial corner of concrete cap encountered.

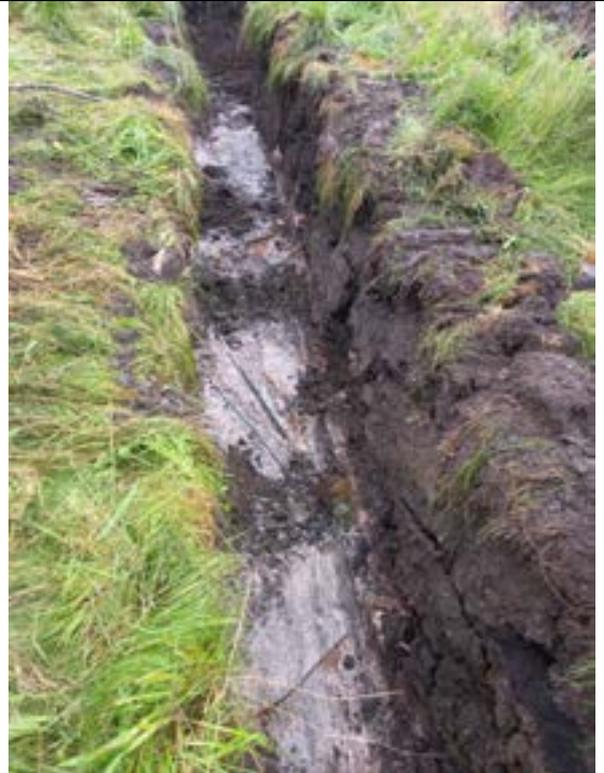
The upper 0.15-0.3m of the concrete cap is noted to be highly weathered with the consistency of a soft gravelly clay. Reinforcement bar approximately 1 inch in diameter was noted to be 'free' and no longer bound within solid concrete across this weathered surface. In some locations the rebar passed deeper into and was anchored by the intact concrete below.

**Photograph 8:**  
Trenching across the shaft cap showing loose reinforcement bar.

At this stage LKC recommend that shafts 369423-011 and 369423-012 are test drilled over safety staging to establish the depth of the shaft and integrity of the fill material within them.

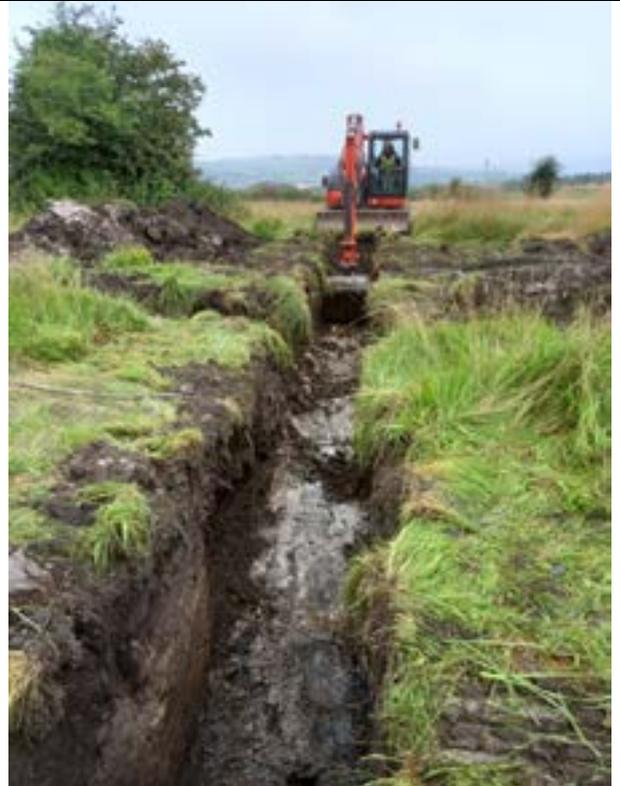
**Photograph 10:**  
Full width and length of the slab exposed east to west and north to south

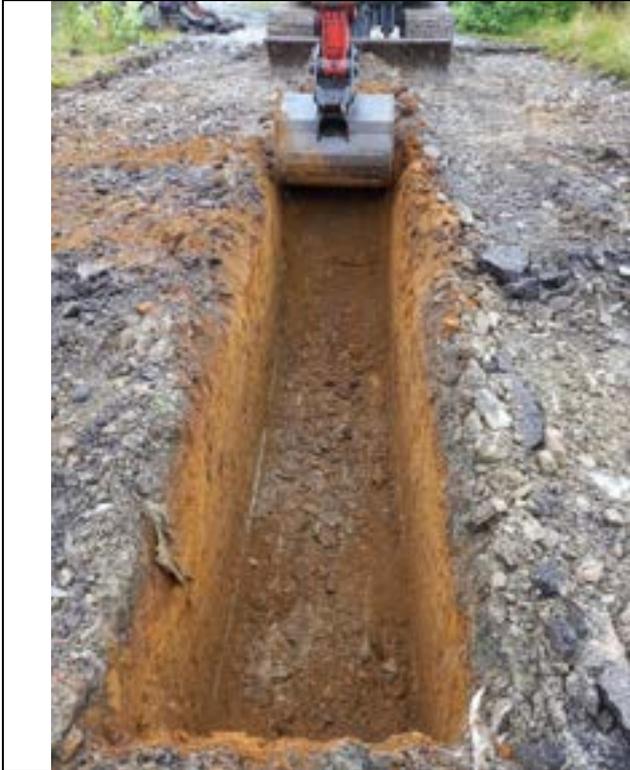
**Photograph 11:**  
Orangish red superficial deposits over sandstone.

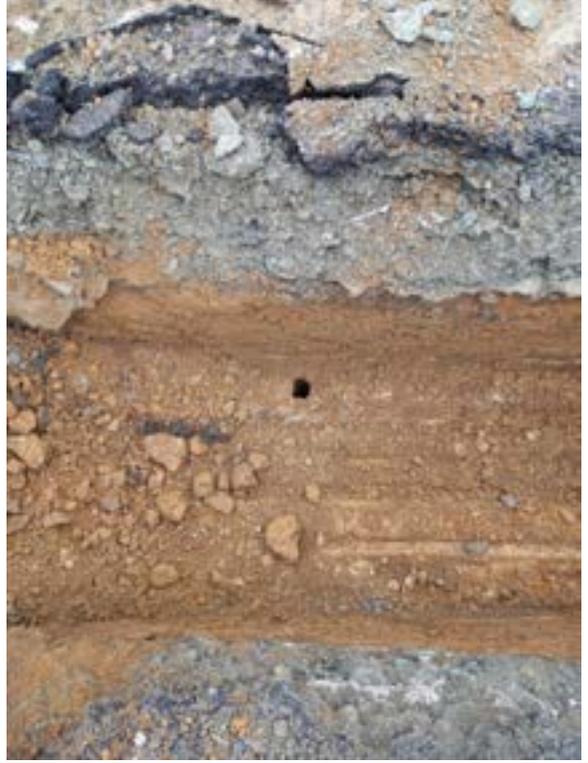
Trial trenches to rock head, encountered from 1.5-2.0mbgl as a orangish red sandstone, were extended out from the mapped location of the shaft across the potential departure. Evidence of the previous investigation works were noted in a number of the trenches in the form of 50-100mm diameter holes into rock head on a 1.5-2m spacing.

**Photograph 12:**  
Evidence of the former investigation works within the trial trenches.

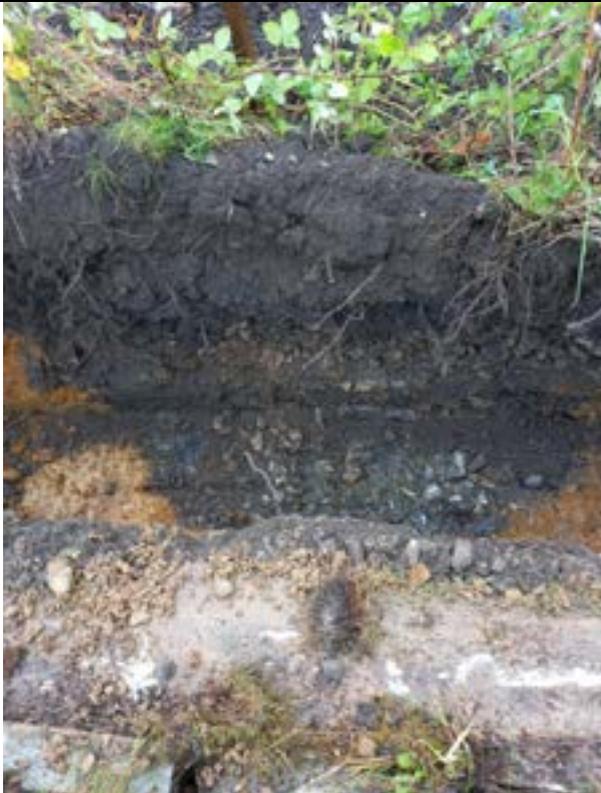
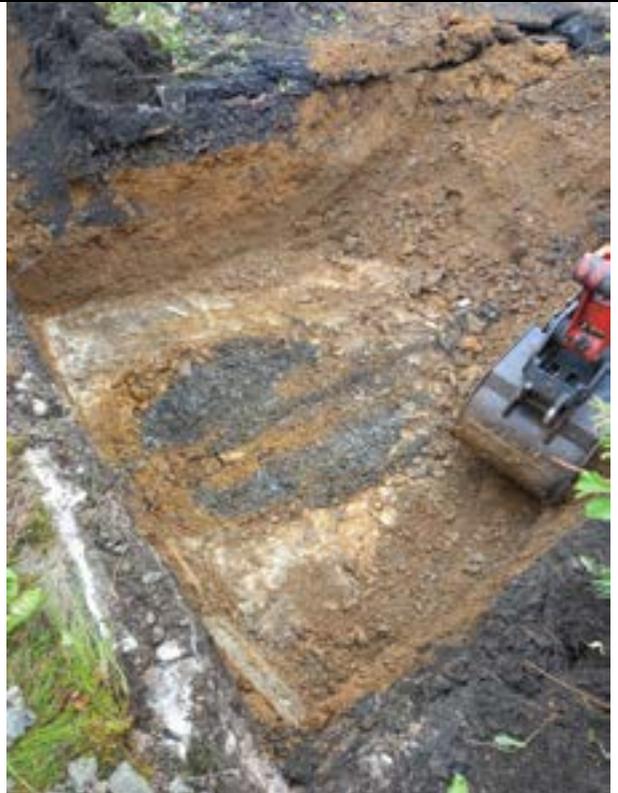
A possible mine entry was located approximately 8m to the south of the mapped mine shaft location. The possible mine entry was shown to be a 1.2-1.5m diameter oval where made ground comprising grey to black ash, clinker and colliery spoil penetrated rockhead.

**Photograph 13:**  
Potential evidence of a shaft exposed.

**Photograph 14:**  
Potential shaft fully exposed.

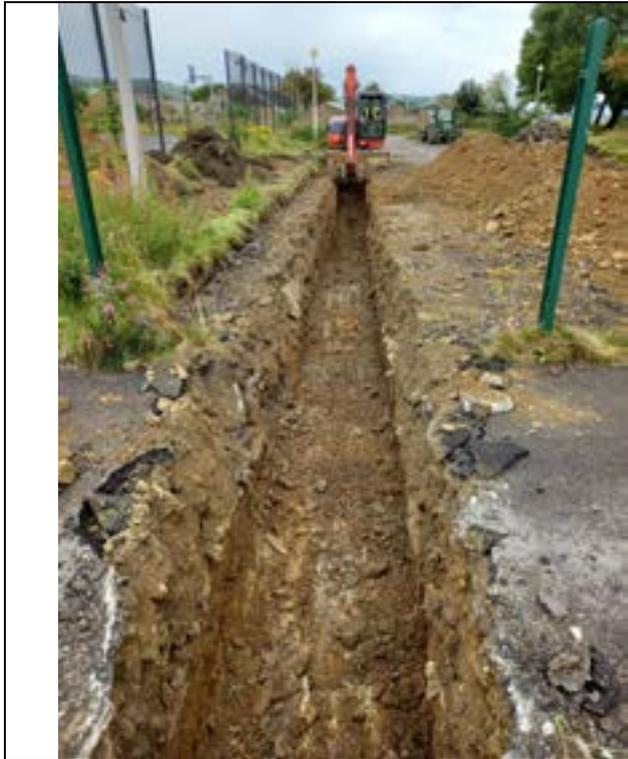
**Photograph 15:**  
Orangish red superficial deposits over sandstone.

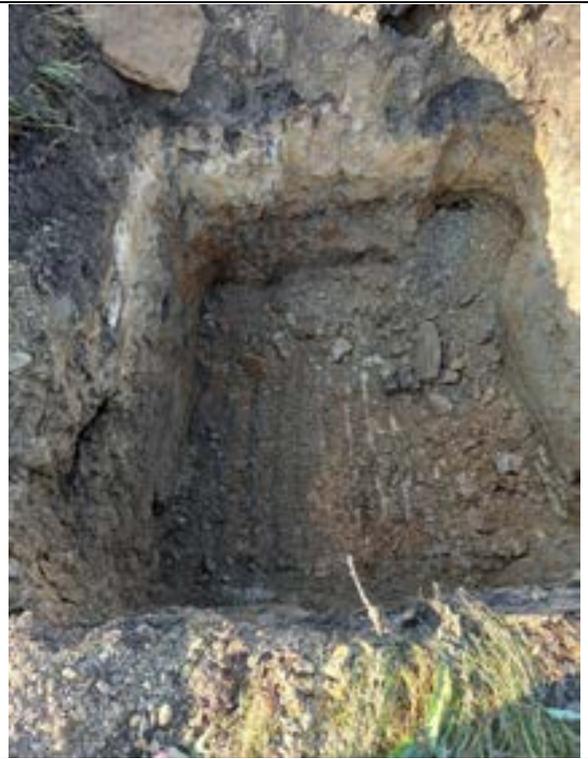
**Photograph 16:**  
Extension of trial trenches in areas of soft or reworked natural.

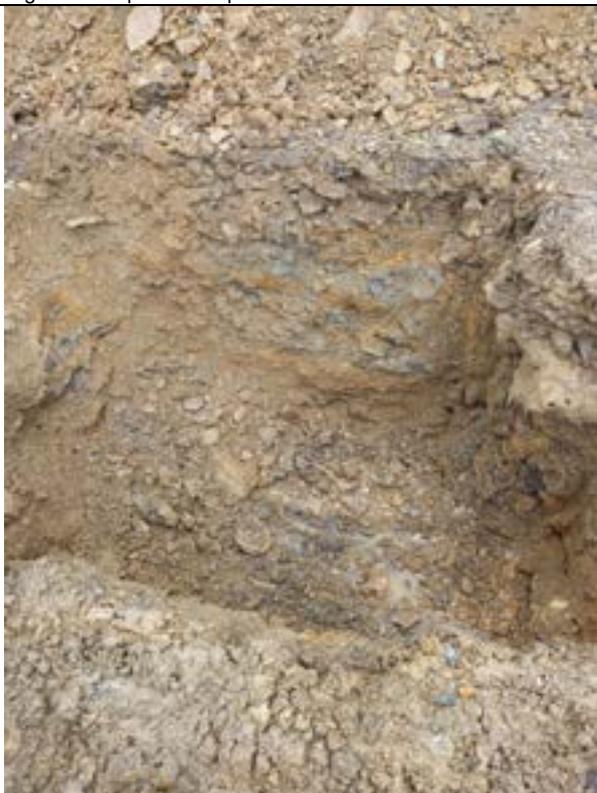
Extensive trial trenching was carried out from the mapped location of the shaft. Evidence of the previous investigation works which identified the adit was noted; where in situ natural strata gave way to disturbed reworked strata with relic organic soils mixed with weathered sandstone rock and sandy clay.

**Photograph 17:**  
Example of reworked ground – likely to represent historic investigations for mine entries.

As shaft/adit 369423-029 could not be located, but evidence of the previous investigations which identified the adit were located, LKC recommends additional

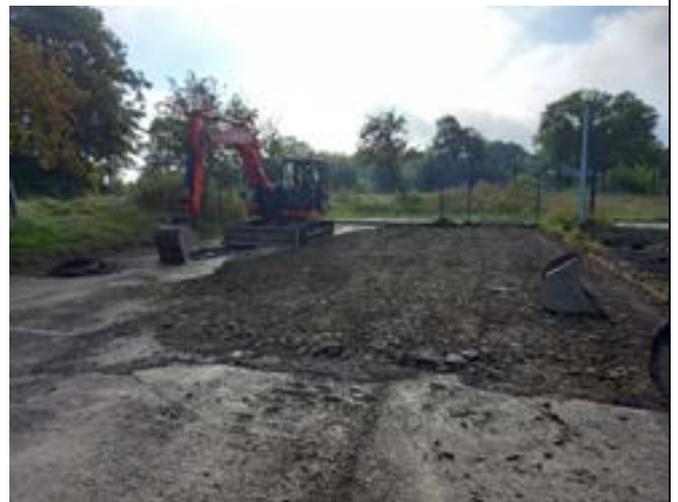
No evidence of the shaft or the adit was recorded identified during the investigation works.

**Photograph 14:**  
View across the area investigated after 1 day.
